Manhole Inspection Summary

Manhole # S27I__046MH

Insp Date: **5/27/08 9:41 AM**

Location Address: **910 W Pratt St**

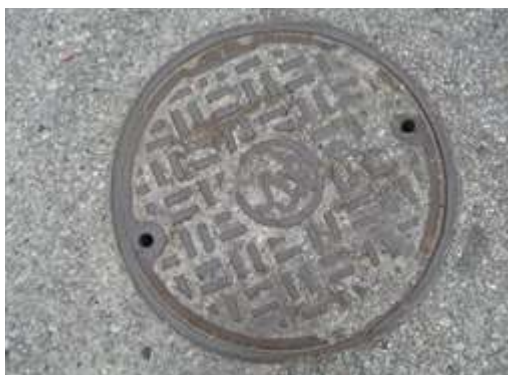
Cover View

Type: **Sanitary** Condition: **Sound** Cover Material: **Cast Iron**

Frame Offset: **2.5** (in.) Condition: ☐ Sound ☐ Cracked ☒ **Leaks**
